# When a Prosthesis or Mobility Device Isn't Enough

by Jason T. Kahle, CPO, and M. Jason Highsmith, DPT, CP

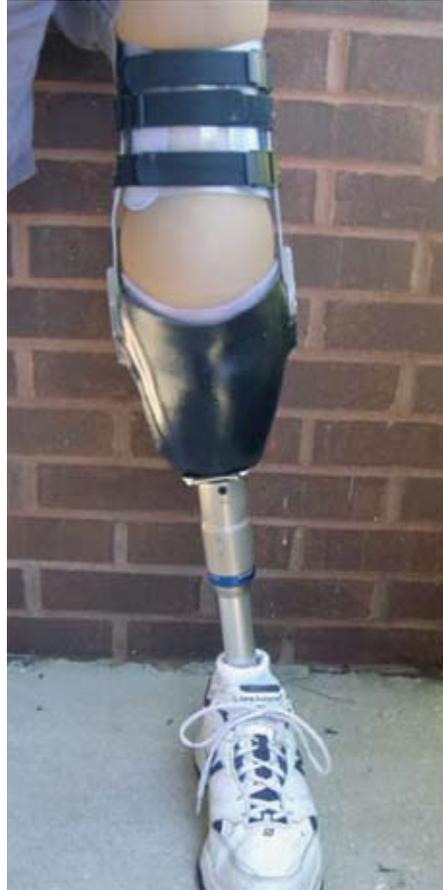
### Figure 3

of a person's knee joint is questionable (Figure 3). First, this is a below-knee prosthesis with a prosthetic socket interface, pylon (shin), and foot. This is the prosthetic portion. Because ligament instability is present, however, orthotic joints are also added to limit the patient's accessory knee movement and prevent it from undesirably stressing the anatomic knee.

*This joint and corset prosthesis has the top half of a knee orthosis (KO) attached to it. This is for two reasons. First, the patient has an extremely short residual limb with insufficient surface area to fully bear weight through it. The KO allows some of the weight-bearing to be transferred to the thigh. Second, it is typical for a patient with a short residual limb to have knee instability because the "lever arm" (the remaining part of the limb below the knee) is too short to support the forces that are placed on the residual limb during weight-bearing. The KO artificially extends the "lever arm" well above the knee to assist it against these forces.*

Often, the user's residual limb is short and/or highly sensitive, and this prosthesis transfers much of the body's weight from the person's thigh through the orthotic joints to the prosthetic foot, thereby bypassing the residual limb. If the joint and corset

prosthesis is needed but not used, the result may be a knee that has excess laxity and instability or a needlessly uncomfortable prosthesis.
